Monitoring Data Record

Project Title: R-2417BB (Site 6) COE Action ID: 200201326
Stream Name: _____ DWQ Numbers: 3378
City, County and other Location Information: Lee County, Sanford Bypass (Sta. 540+20 to 555+00 -L- RT.)
Date Construction Completed: Water was turned into the stream in Oct. 2006. Streambank reforestation was completed in Jan. 2007.
Monitoring Quarter: (3) of 8
Ecoregion: _____ 8 digit HUC unit: 03030004
USGS Quad Name and Coordinates: _____

This is the 3rd quarterly monitoring evaluation for this stream relocation. The stream is stabilized except for a crossvane located at approx. Sta. 546+75. The contractor was made aware of the problem and repaired the crossvane failure on November 30. Last quarter a crossvane located at approx. Sta. 545+60 had water piping under. This crossvane now has water flowing over the structure. NCDOT will continue to monitor this stream relocation.

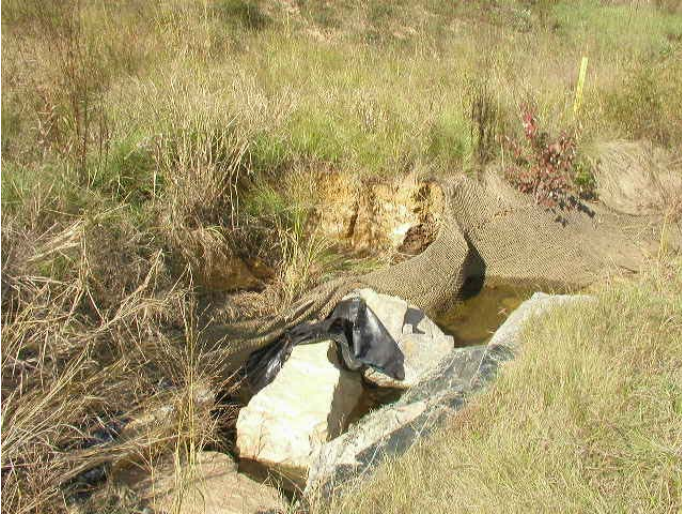
11/2/07	Sta. 546 +75	Station Number	Station Number	Station Number	Station Number
Structure Type	Crossvane				
Is water piping through or around structure?	Water is piping under the crossvane				
Head cut or down cut present?	Slight headcut				
Bank or scour erosion present?	Left arm of crossvane has dropped into channel				
Other problems noted?

Crossvane failure @ Sta. 546+75
